Assessment of Dam Safety of Coal Combustion Surface Impoundments

Indianapolis Power & Light Company

Petersburg Generating Station

Draft Report

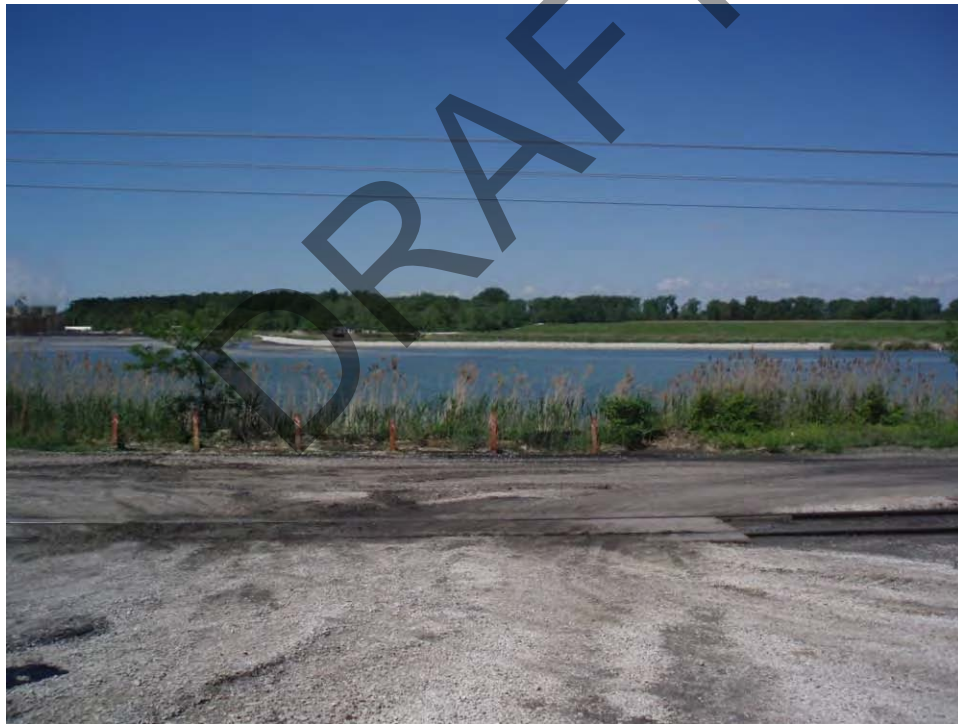
2. Overview of Pond A and east slope of divider embankment, looking west

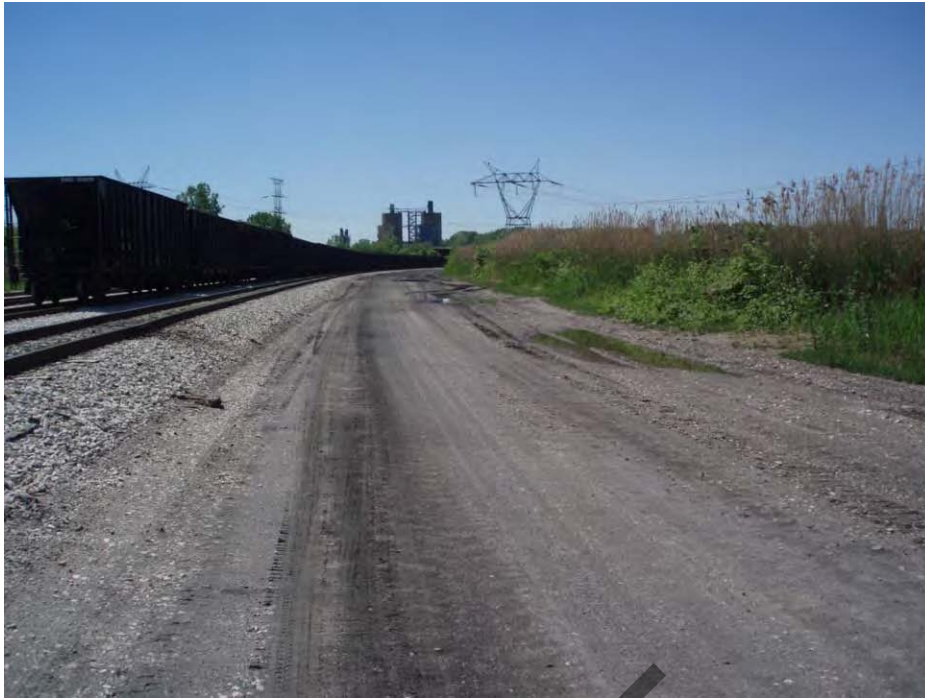
3. Pond A – East embankment crest, looking south.

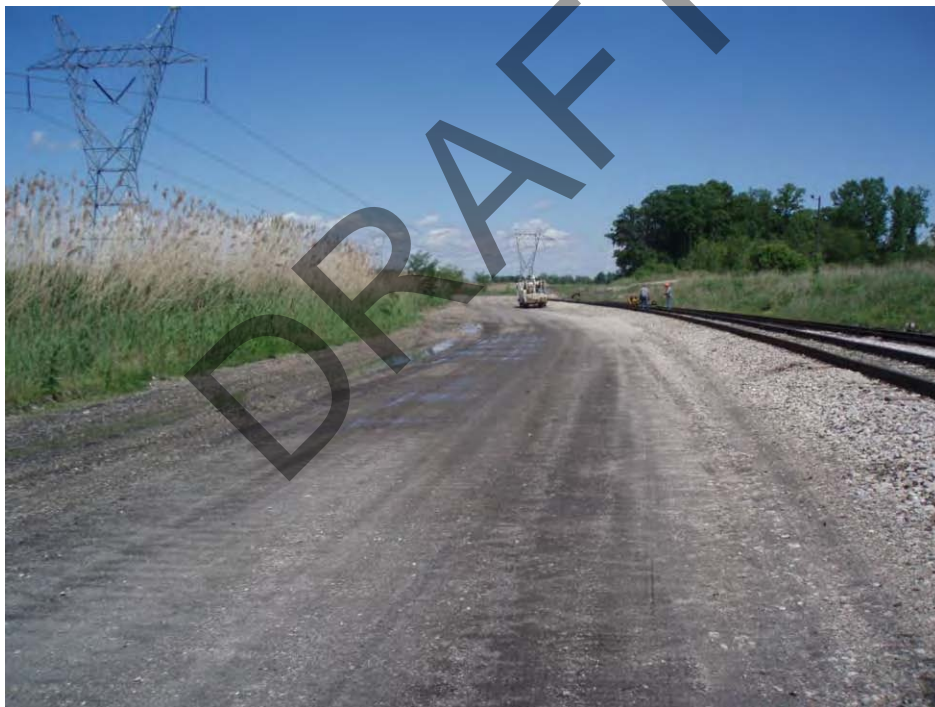
4. Pond A – East embankment crest, looking north

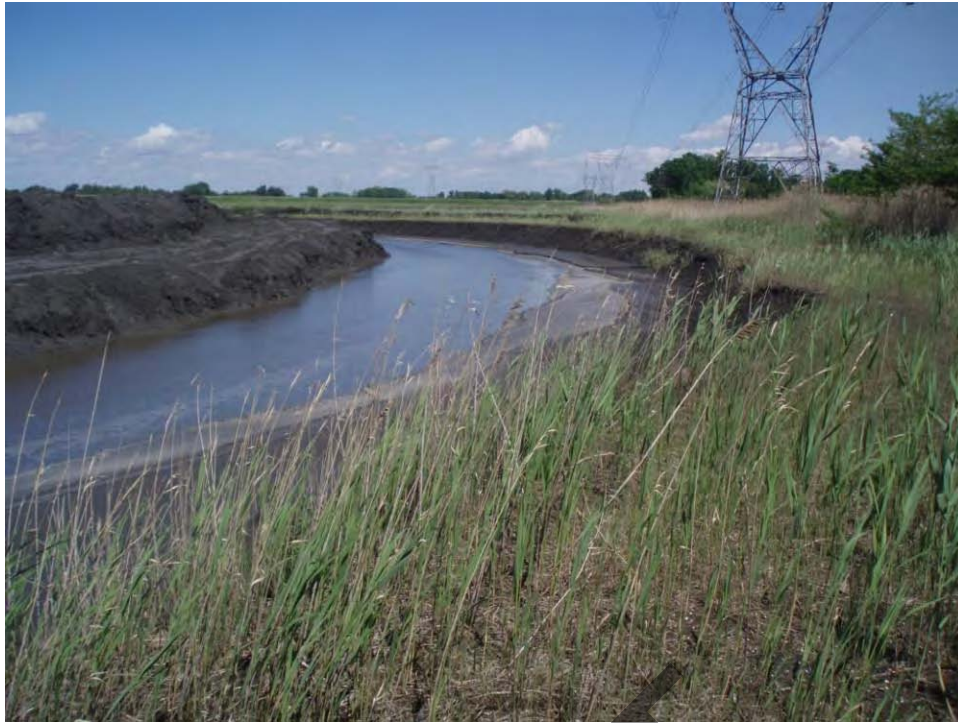
5. Pond A rim ditch, looking north.

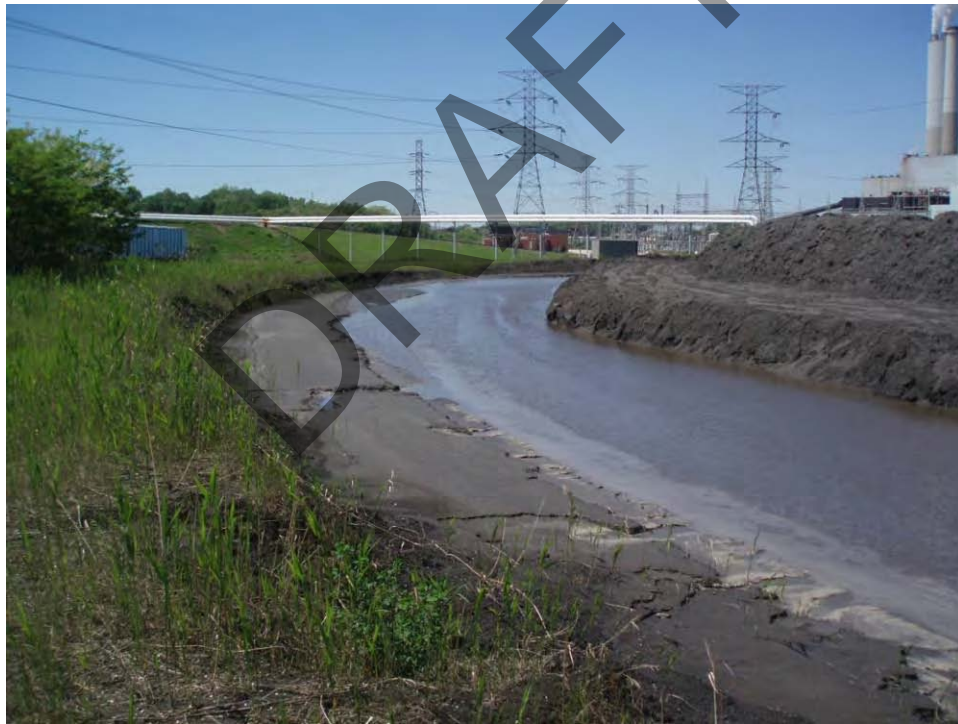
6. Pond A rim ditch, looking southeast.

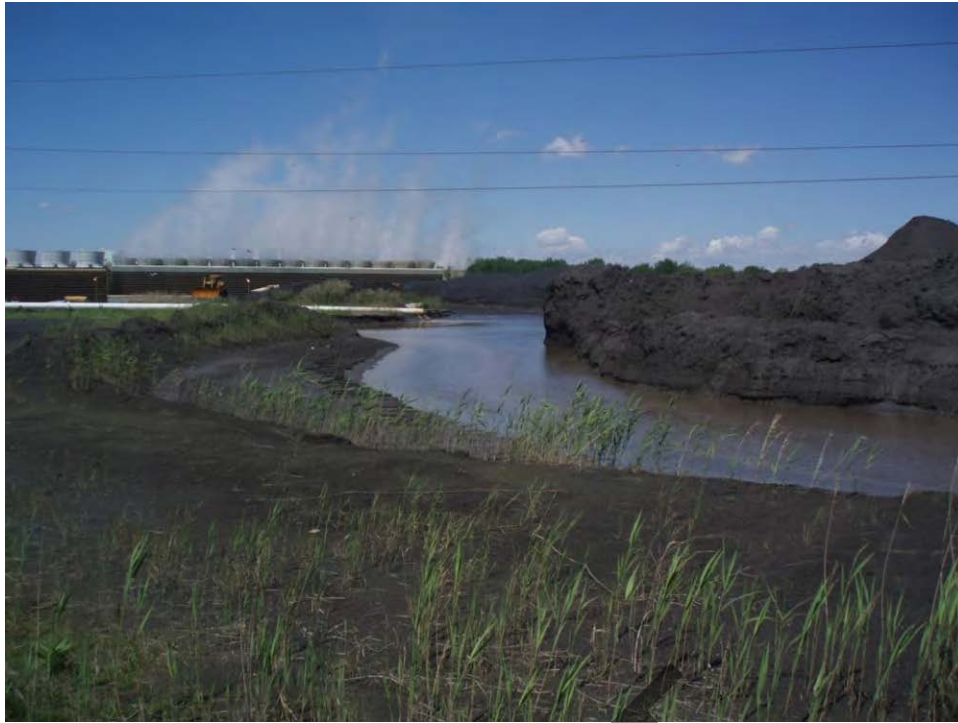
7. Pond A rim ditch looking west at sluice pipes.

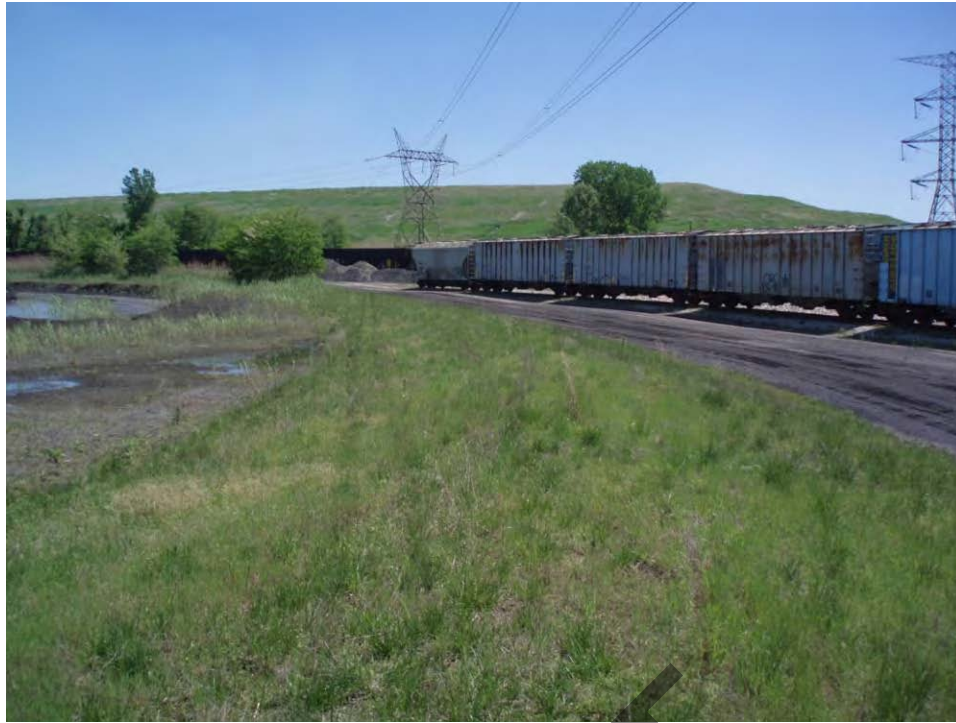
9. Pond A – South embankment crest, looking east.

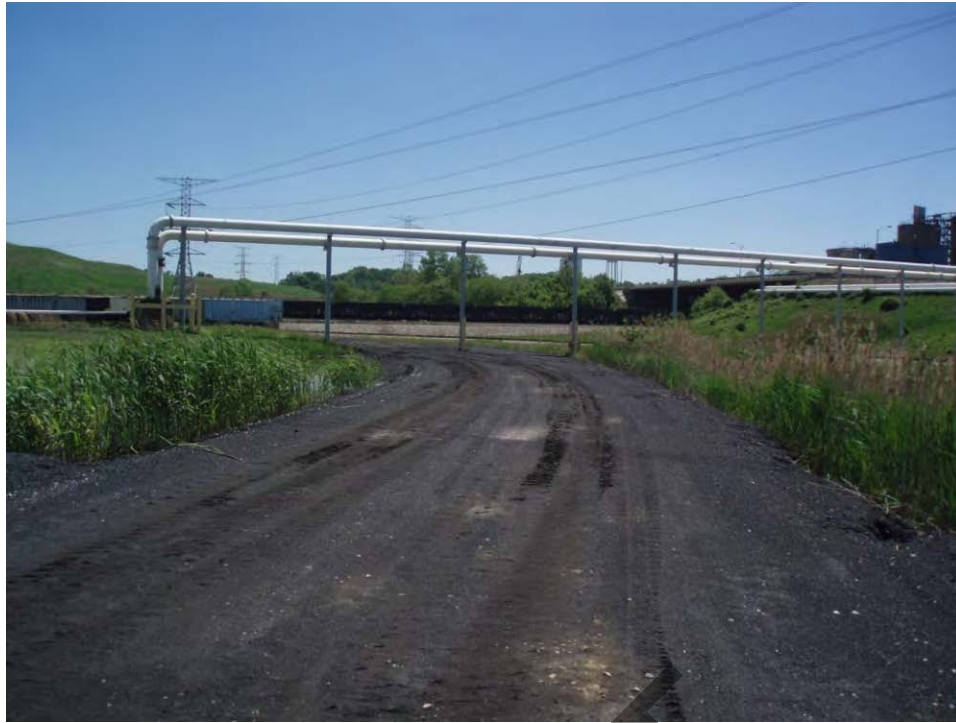
11. Pond A – South embankment looking southeast.

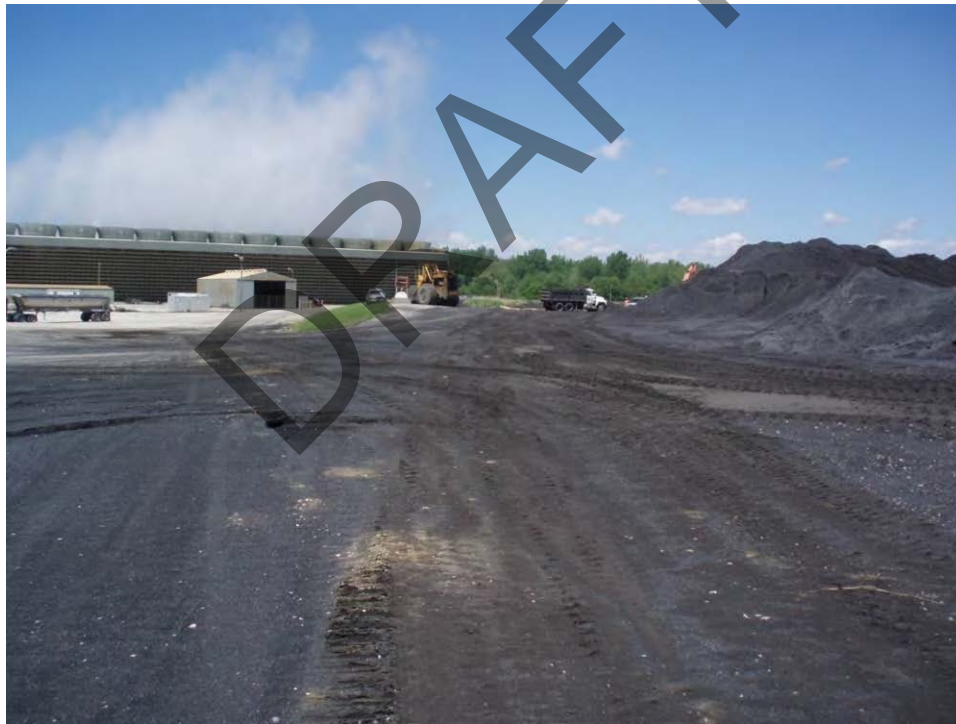
12. Pond A – South embankment crest, looking northwest.

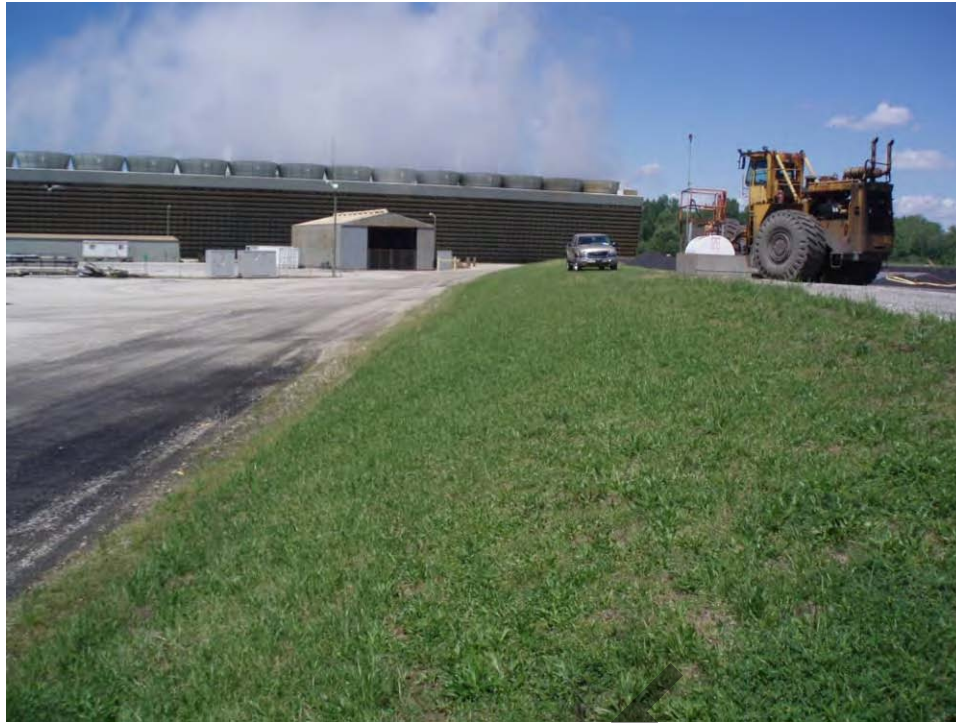
13. Pond A - South embankment exterior slope, looking northwest.

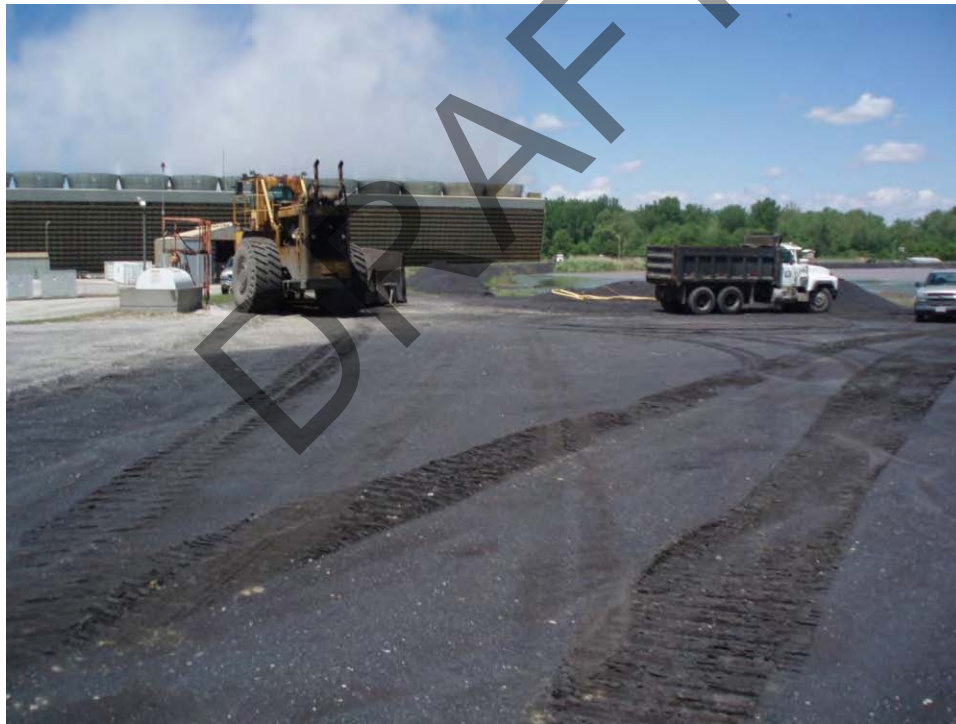
14. Pond A - South embankment crest, looking northwest.

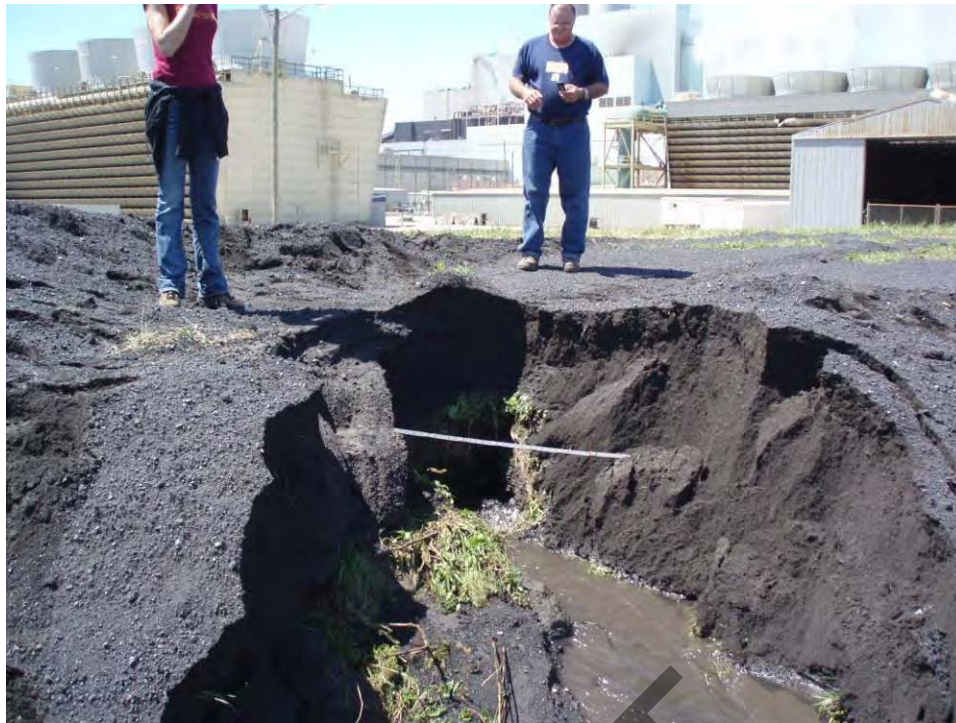
15. Pond A – Active erosion/piping of south embankment interior slope from unknown water source. Water was clear. Eroded area 5'Wx8'Lx3.5'D. IPL personnel were trying to determine source of flow.

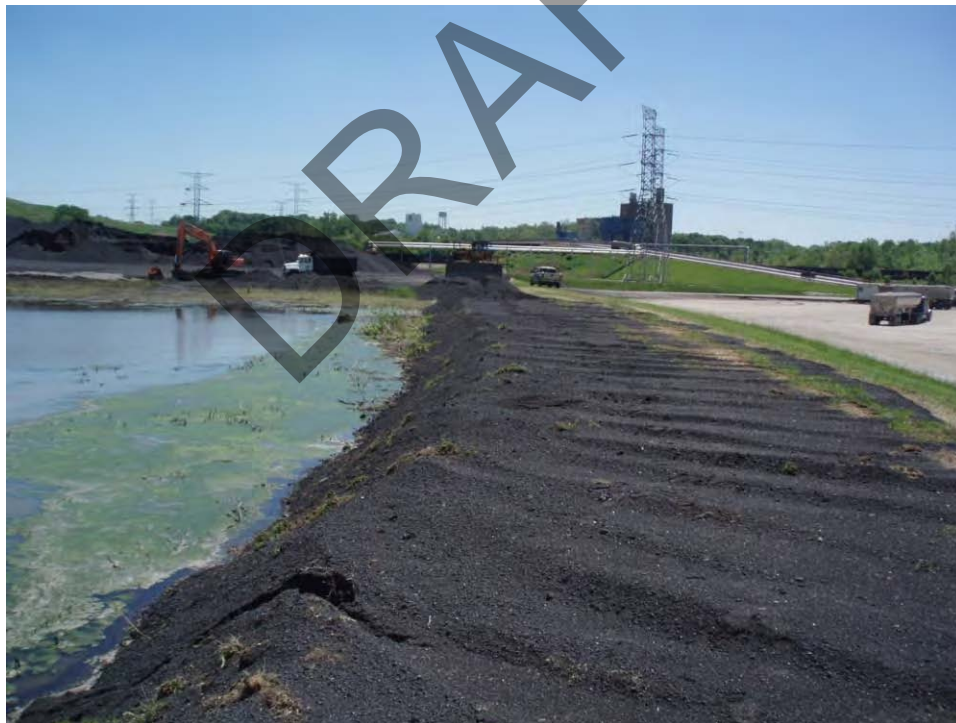
16. Pond A – South embankment crest, looking southeast at recently placed ash material. Note existing embankment was not cleared or grubbed before placing material.

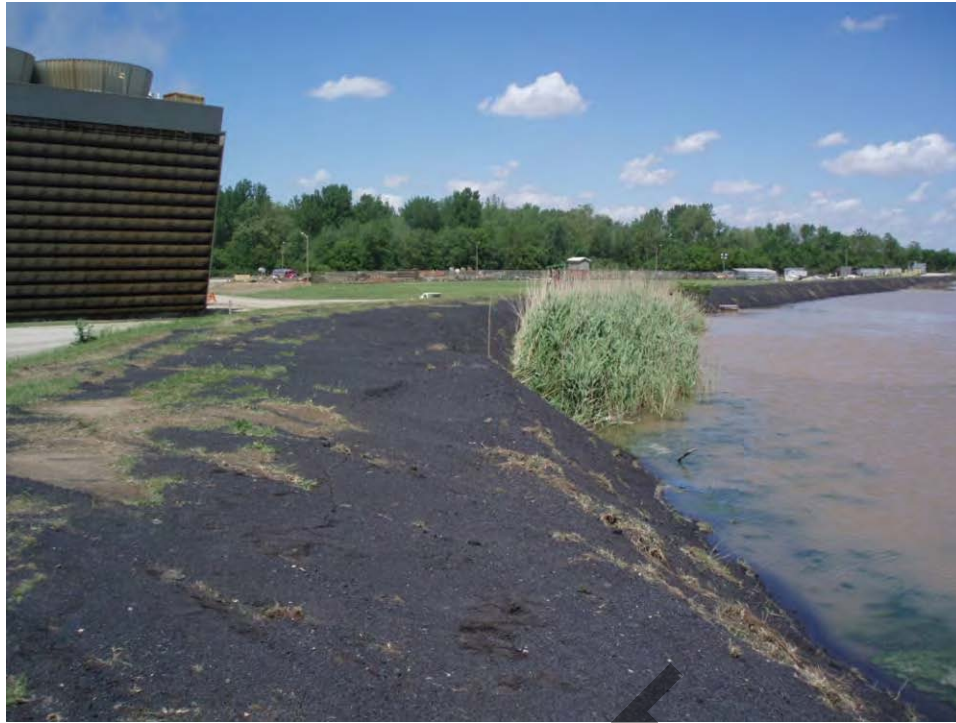
17. Pond A – South embankment crest, looking northwest at recently placed ash. Note existing embankment was not cleared or grubbed before placing material.

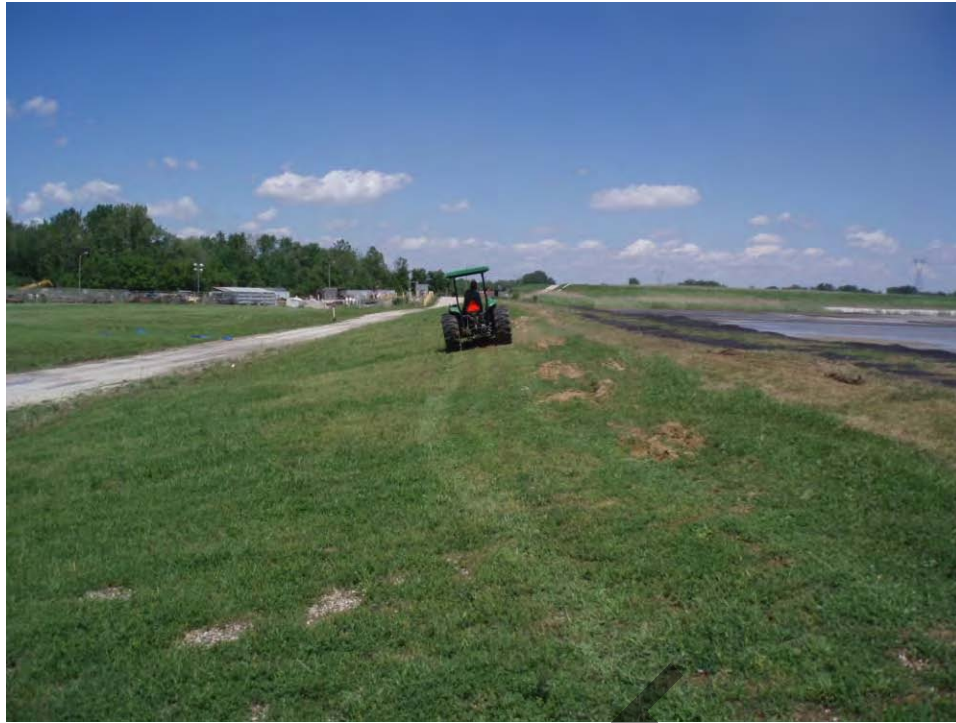
19. Pond A – West embankment exterior slope, looking north at mowing operation.

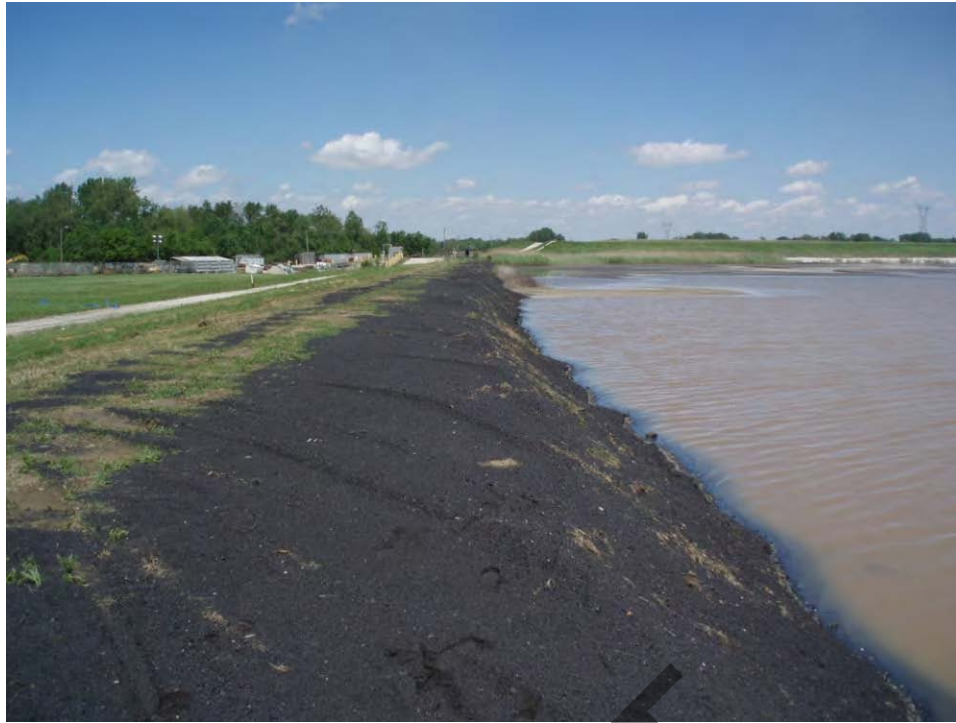
21. Pond A – West embankment interior slope and crest, looking north

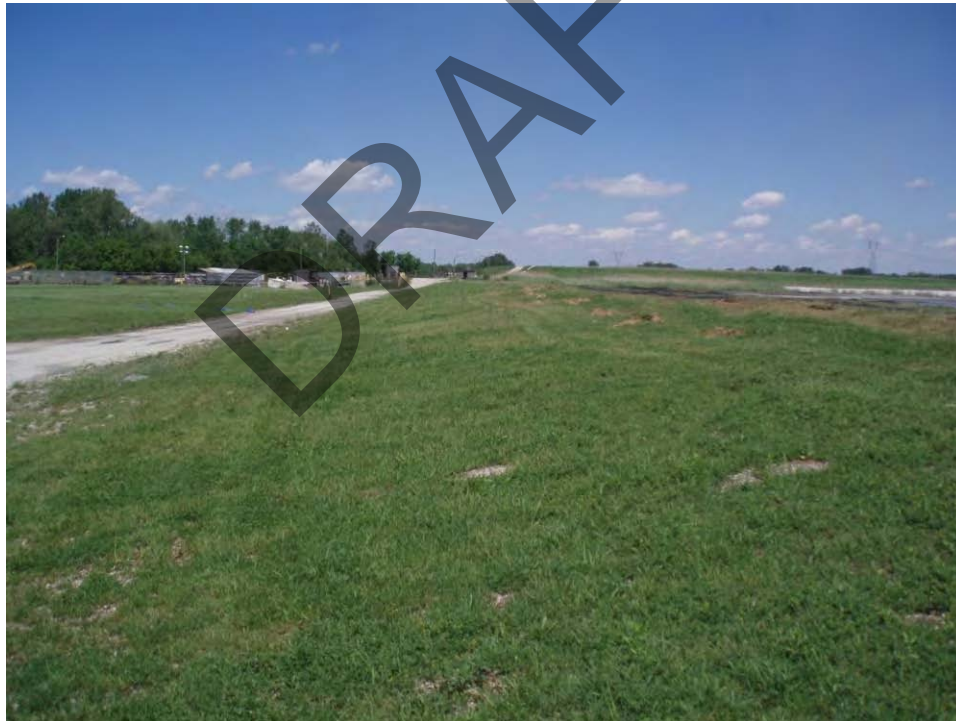
22. Pond A – West embankment exterior slope, looking north.

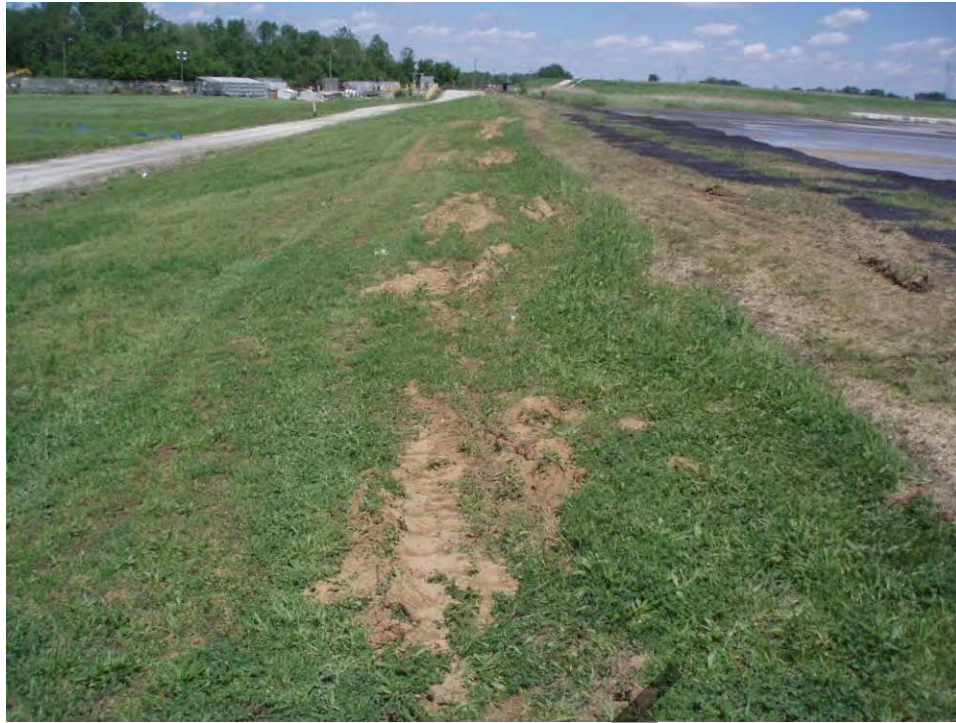
23. Pond A – West embankment exterior slope, looking north at tractor ruts.

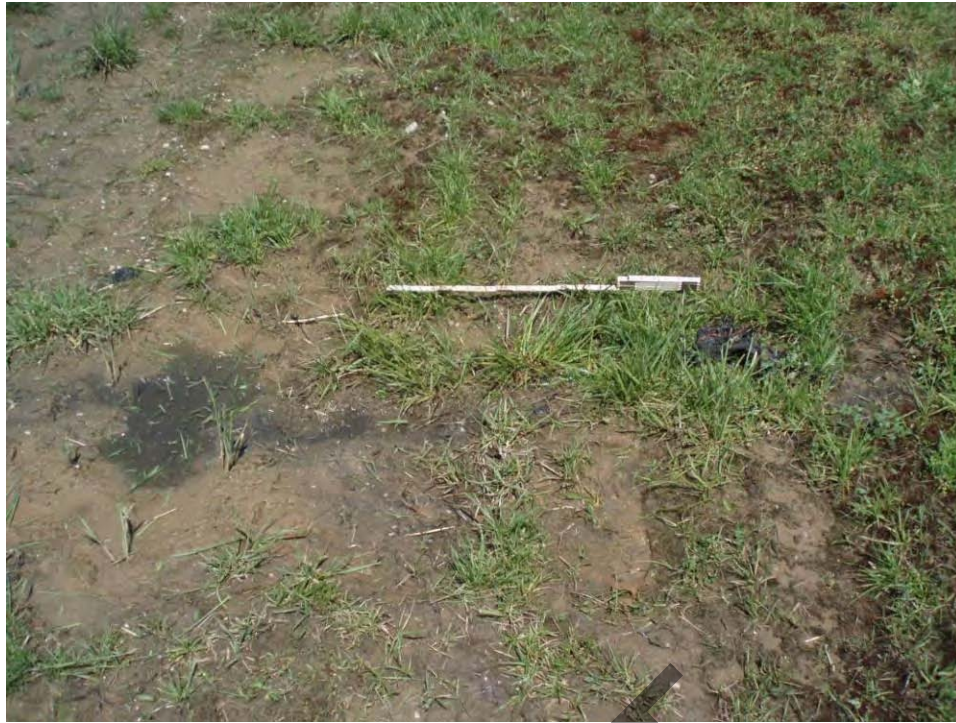
25. Pond A – Saturated area on west embankment exterior slope.

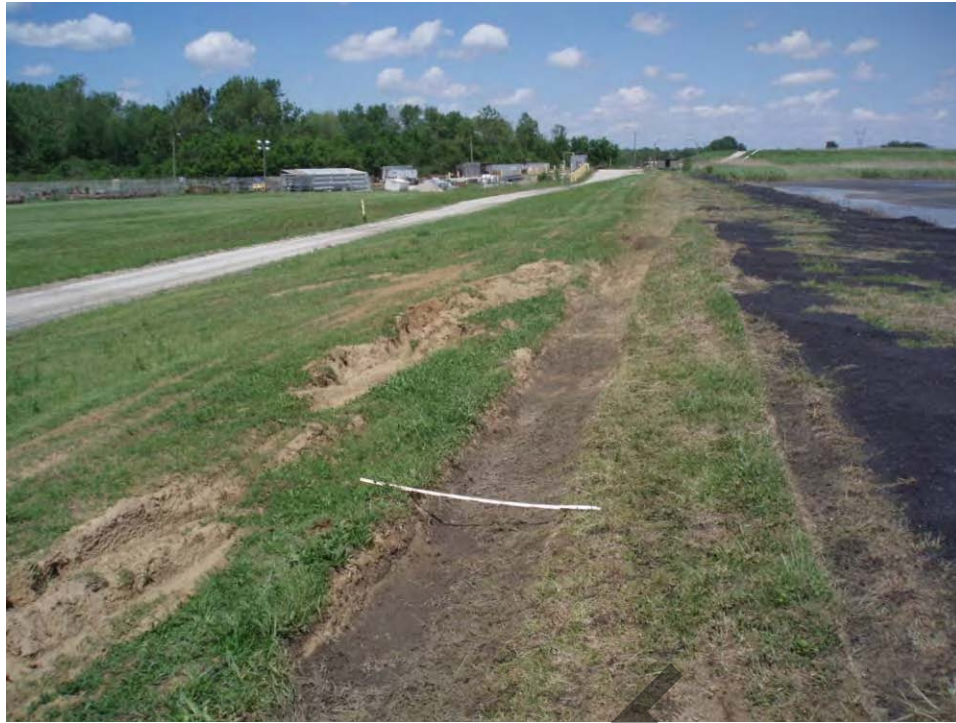
27. Pond A – West embankment exterior slope, looking north at large tractor ruts and excavator tracks.

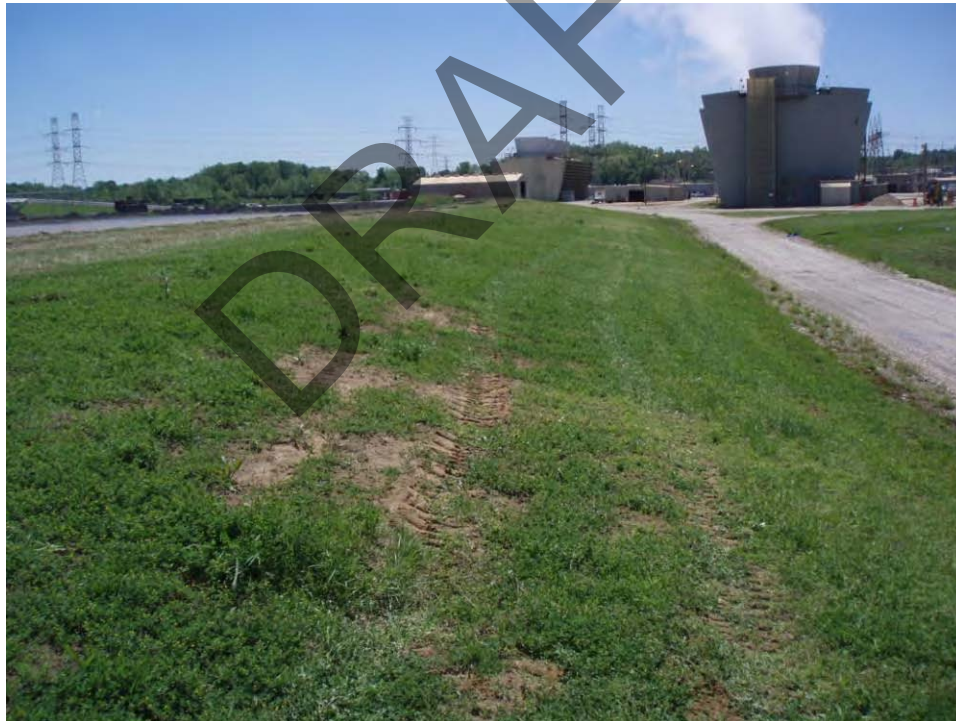
28. Pond A – West embankment exterior slope, looking south.

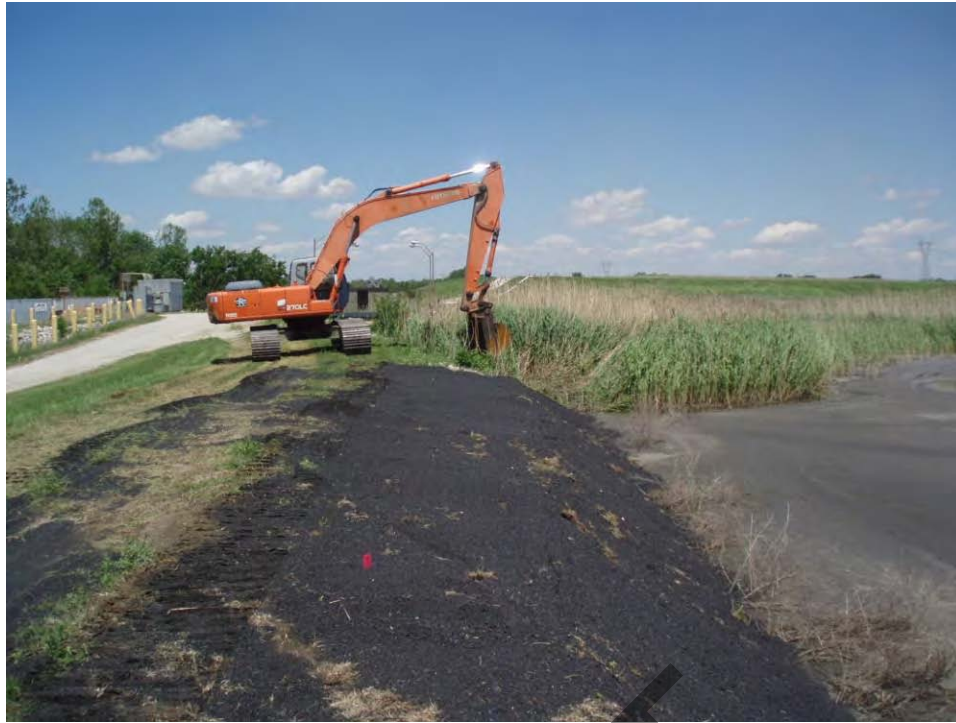
29. Pond A – West embankment interior slope looking north at embankment work.

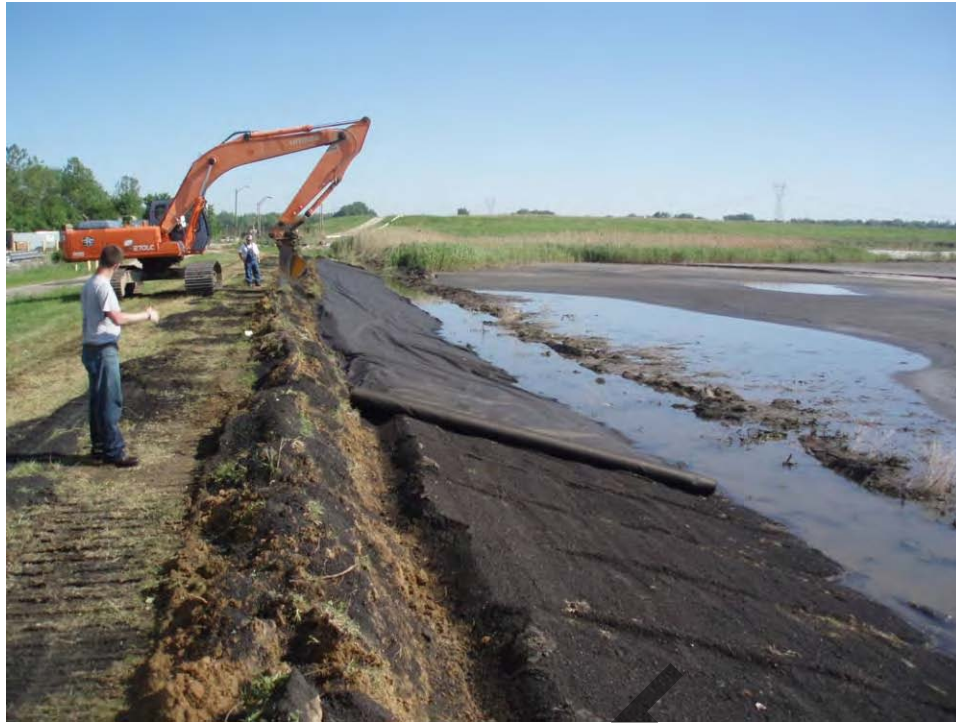
31. Pond A - West embankment interior slope, looking north at rough embankment grading. Note Mirafi geofabric does not extend to the toe of the slope.

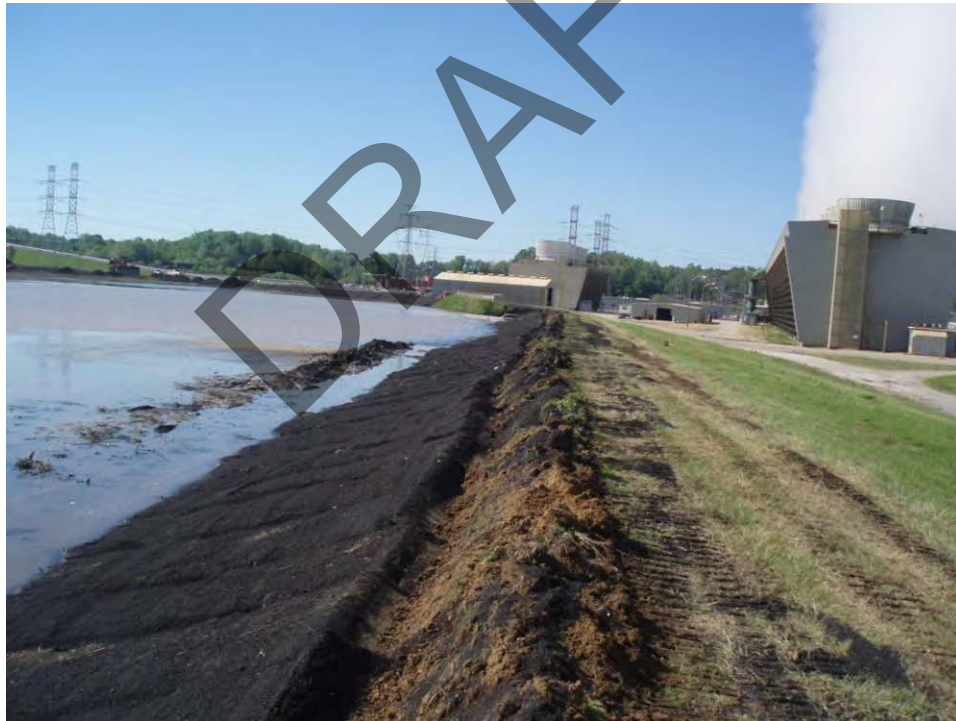
32. Pond A - West embankment interior slope, looking south at rough embankment grading

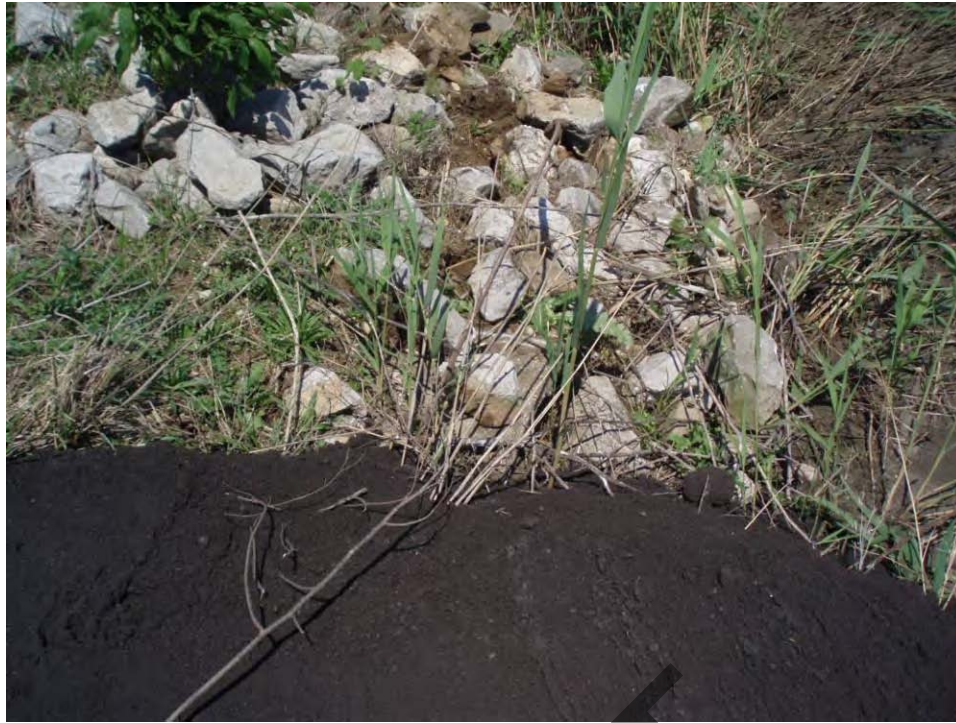
33. Pond A – 24-inch-diameter RC pipe being covered by ash.

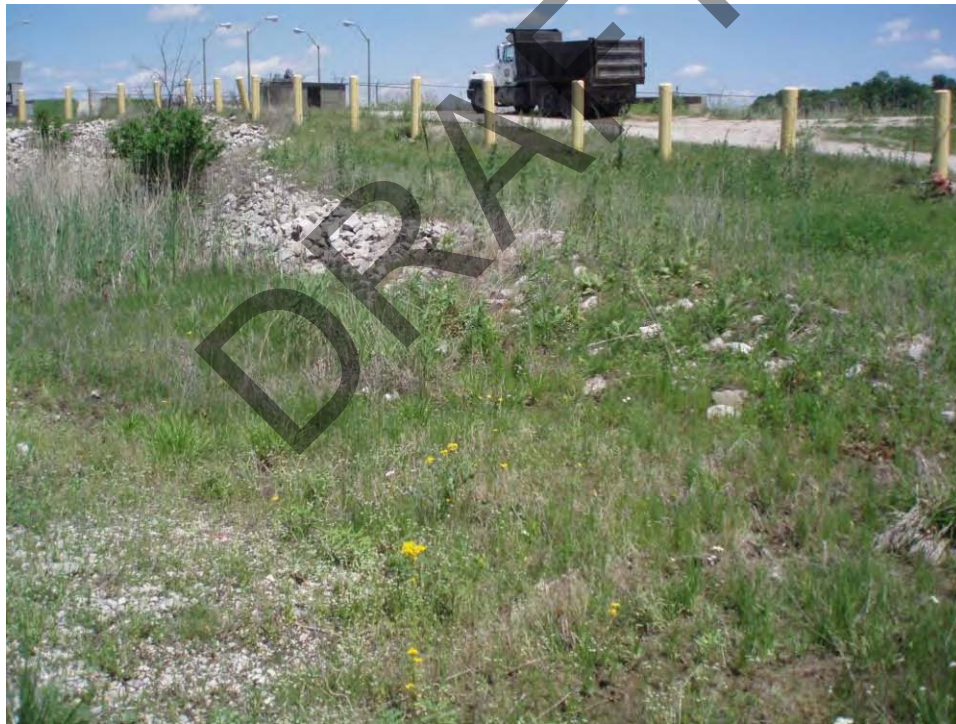
34. Pond A – Former location of Lick Creek at west embankment exterior toe.

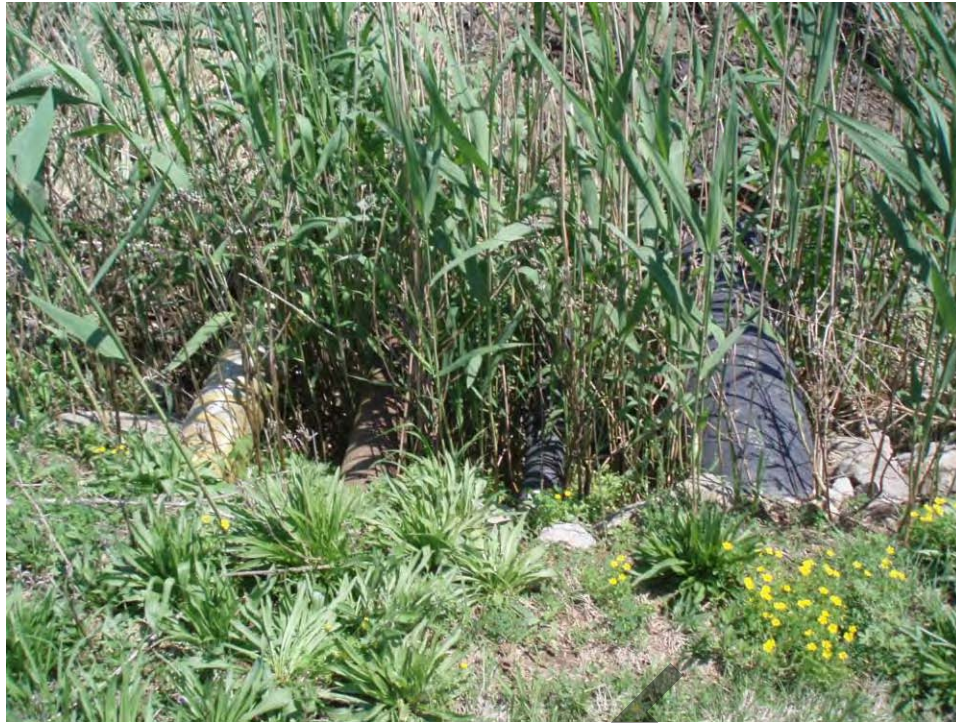
35. Pond A – Looking east at inactive 4-, 6-, 8-, and 15-inch-diameter sluice pipes from unknown origin. Use unknown.

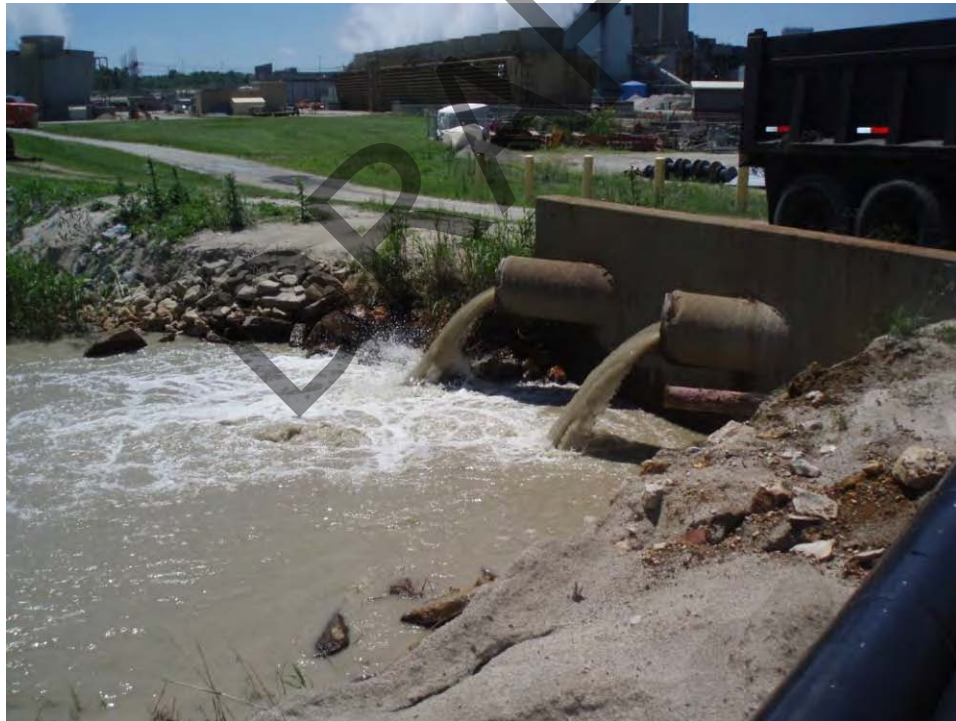
36. Pond A – West embankment interior slope, looking southeast at two (2) 24-inch-diameter RCP from plant super sumps and one (1) 4-inch-diameter DI pipe from unknown origin.

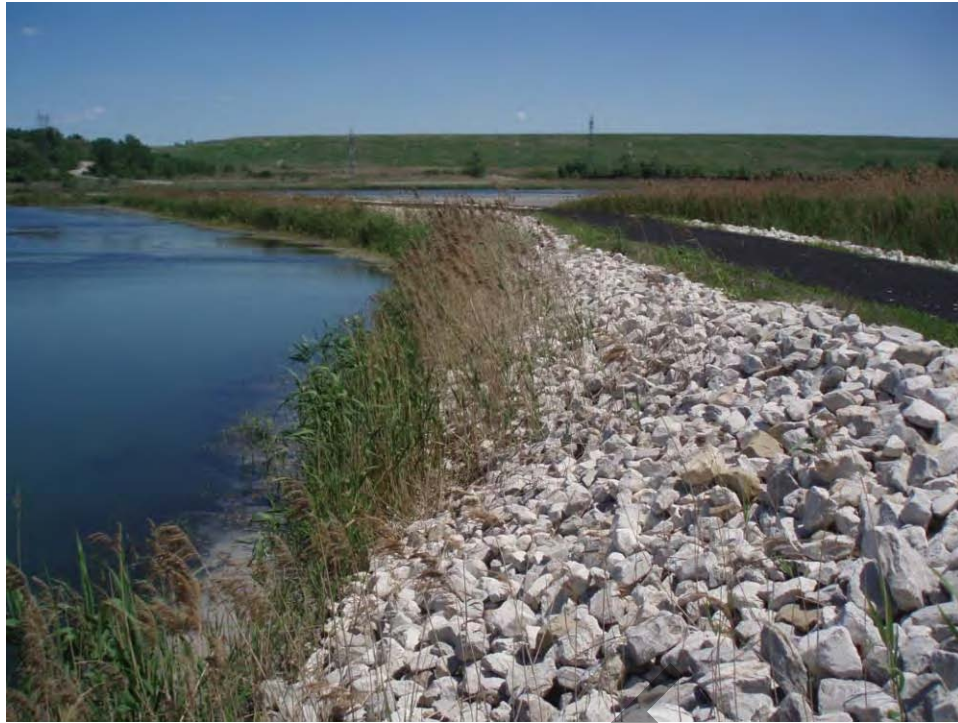
37. North slope of divider embankment between Pond A and Pond A - Discharge, looking east.

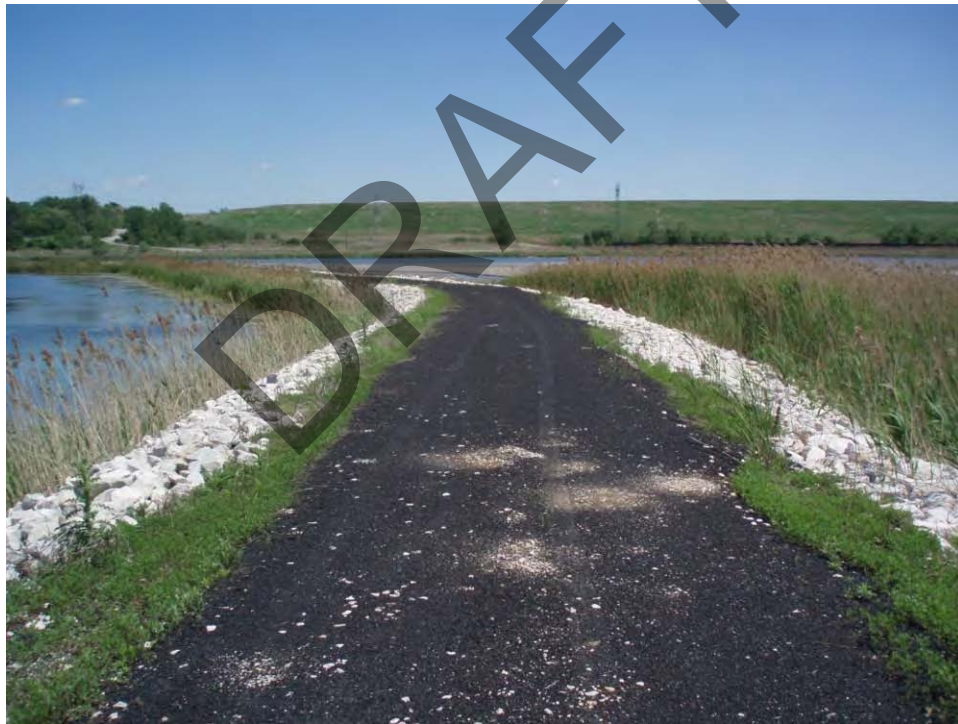
38. Crest of divider embankment between Pond A and Pond A - Discharge, looking east.

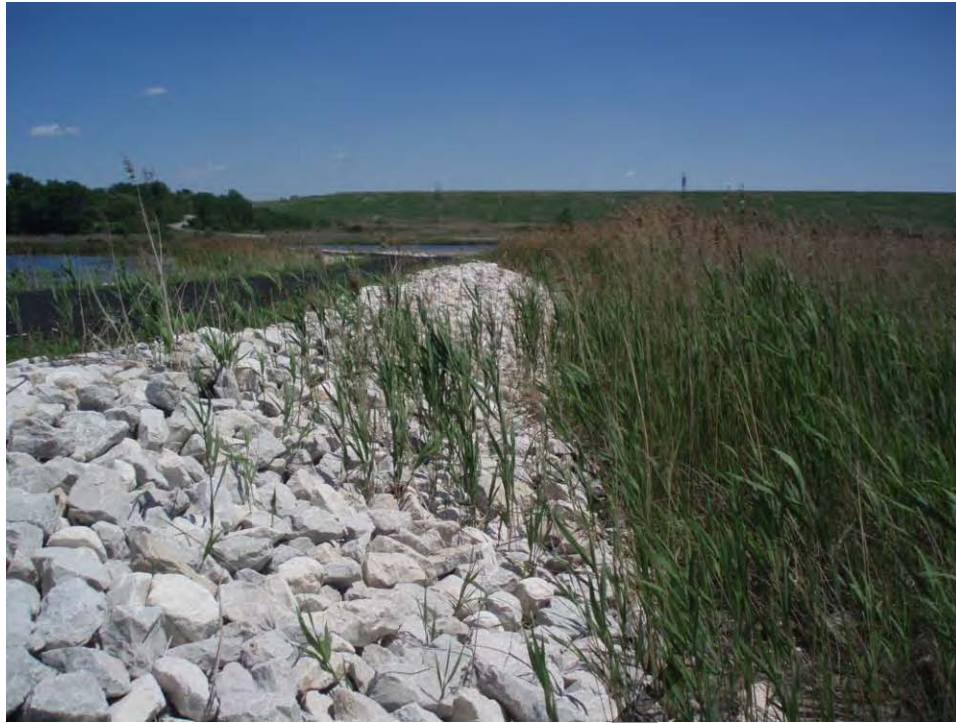
39. South slope of divider embankment between Pond A and Pond A - Discharge, looking east.

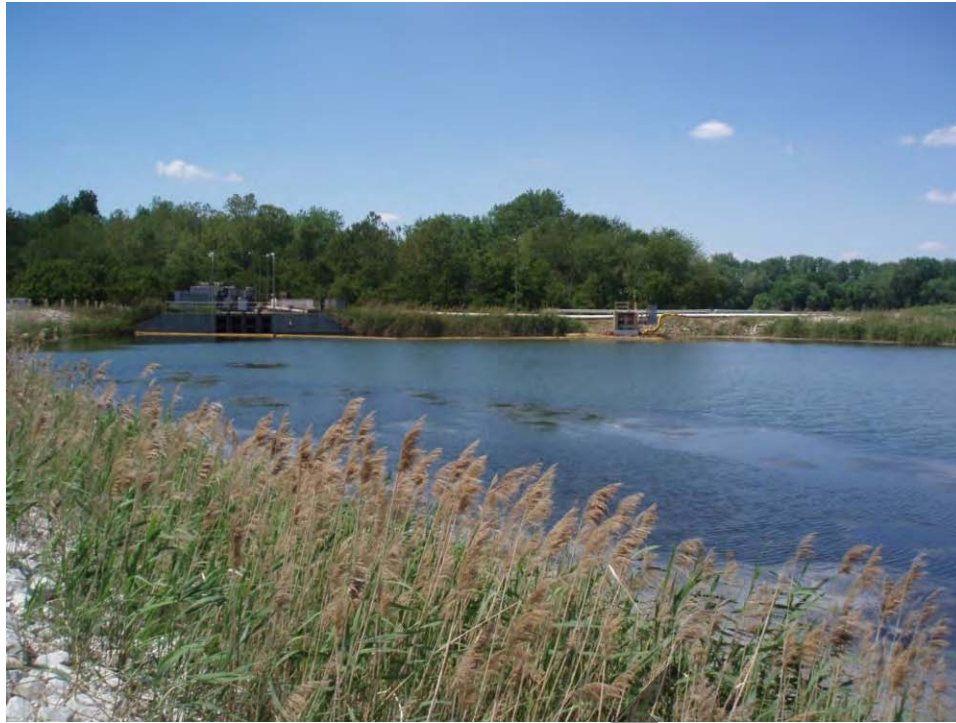
41. Overview of Pond A – Discharge recycle pump station and outlet structure, looking west
